melett

SHAFT AND WHEEL DEVELOPMENT

Development introduction

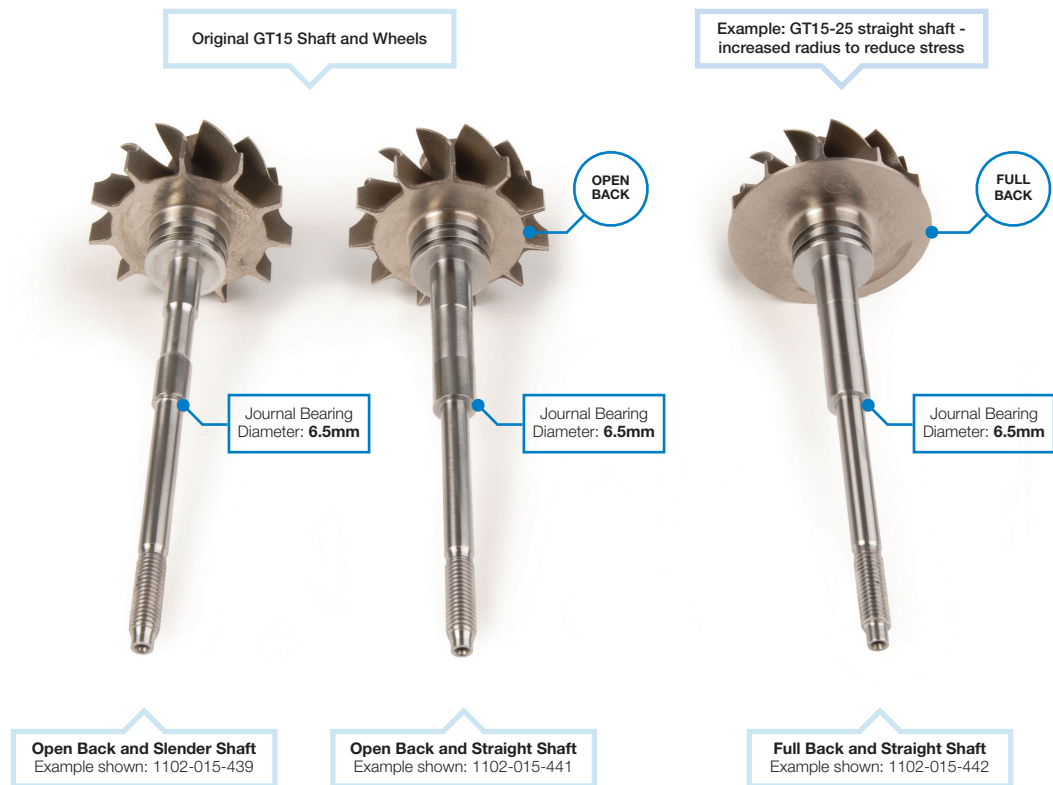
Examples of original and improved parts

Common turbo failures such as overspeeding can cause severe fatigue to the shaft and wheel. Signs of fatigue include partial loss of blades caused by the constant flexing of blades beyond the designed parameters. *Fatigue is a mode of failure not the cause.*

Traditionally, a shaft and wheel has an open back with a slender or straight shaft. To strengthen the turbine wheel, Melett has developed a **full back** shaft and wheel solution that reduces the risk of fatigue on the inducer diameter.
